Coastal Bluff Recession and Impacts on Littoral Transport: Special Reference to  
Montauk, NY

**Abstract**

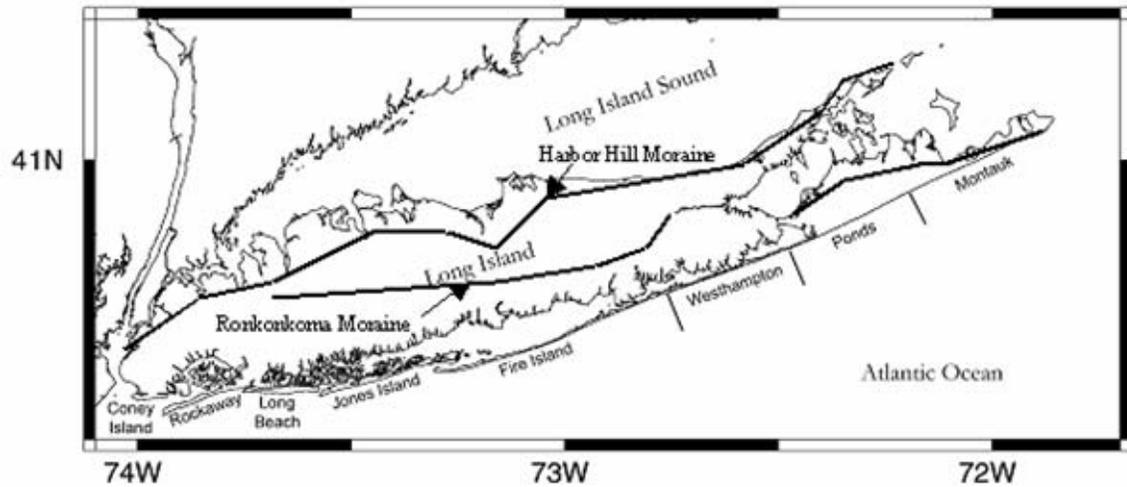
Figure 1. Map shows Long Island, NY with the solid black lines indicating the approximate location of the Harbor Hill and Ronkonkoma Moraines.

Long Island (Figure 1) is 190 km long extending from the Narrows at the entrance to New York Harbor eastward to Montauk Point (Morang et al. 1999). It is the largest island adjoining the continental United States, even though the U.S. Supreme Court has declared recently that it is not an island (Burbidge 2004). Long Island is bound by the Long Island Sound along the north coast, on the east and south by the Atlantic Ocean, and on the west coast by New York Bay and the East River (which really isn't a river, by the way; but a tidal strait). Peconic Bay, which is about 46 km long, divides the eastern end of the island into two long narrow peninsulas locally referred to as the North and South Forks. Montauk Point is located at the eastern tip of the South Fork.

morainal and outwash accumulations associated with the continental glaciers (Fuller 1914). Two end moraines run the length of Long Island. The southern moraine (Ronkonkoma) extends to Montauk Point, and the northern moraine (Harbor Hill) forms Orient Point. The moraines are superimposed along the western part of northern Long Island resulting in relatively high relief. The moraines bifurcate in eastern Long Island, where each moraine forms the core of the two “forks” north and south of Peconic Bay (Figure 1). The Ronkonkoma moraine on the southern fork extends eastward beneath the Atlantic Ocean to Nantucket, Massachusetts (Schwab et al. 1999).

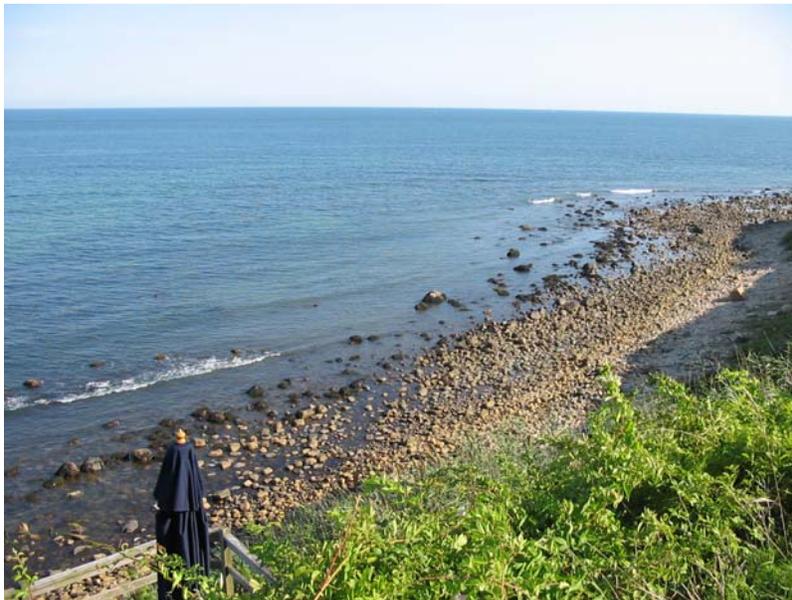
Figure 2. Erosion of the coastal bluffs along the Atlantic coast of Long Island has created boulder reefs and gravel beaches.

wave action (Williams 1976). From the east end of Shinnecock Bay to the beginning of the Montauk Bluffs, there are a series of welded barriers or bay-mouth bars that separate small freshwater ponds occasionally breached by natural and artificial mechanisms. East of Southampton the Ronkonkoma Moraine abuts the Atlantic Ocean and meanders along the coast through Montauk Point. The coastal bluffs here reach elevations greater than 24 m (Morang et al. 1999; Kana 1995). Gradual erosion of the unconsolidated glacial till has resulted in the formation of boulder reef headlands and gravelly pocket beaches (Figure 2).

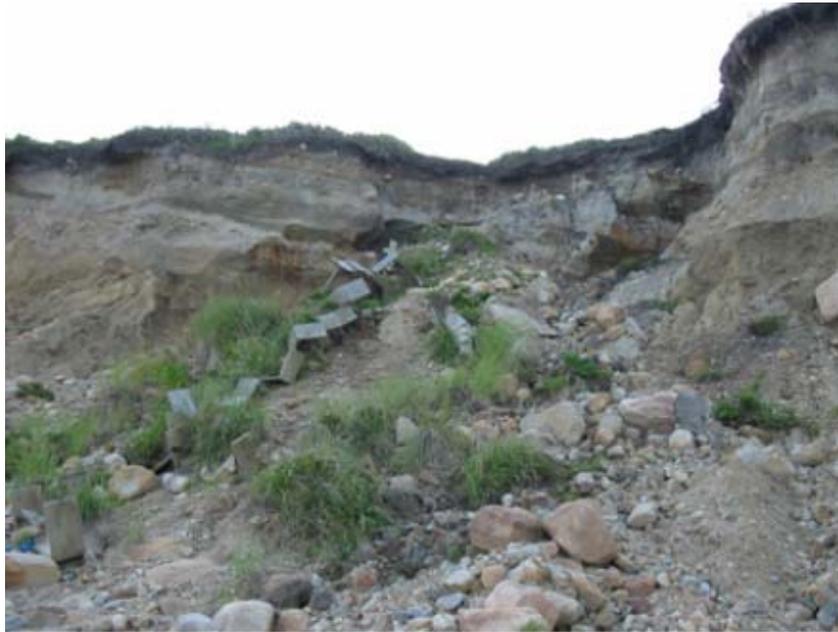
**Figure 3. Photograph of mass wasting of the bluff face. The crest of the bluff recedes as material is transported down slope in the form of a debris slide. Remnants of terracing can be seen intertwined with boulders and gravel. Debris flows and slumps often carry vegetation as a coherent form.**

Although bluffs are continually eroded by precipitation and runoff, they deliver most sediment to the littoral zone through mass wasting processes. Bluffs may remain stable for decades then suddenly slump, receding several meters in a single event (Figure 3). Bluffs are a natural protective feature that can only be generated (for the case of Long Island) through glacial processes. Bluffs, of course, can only erode or stay stable, not accrete; and some bluff erosion must be allowed to proceed to supply sand to the beaches.

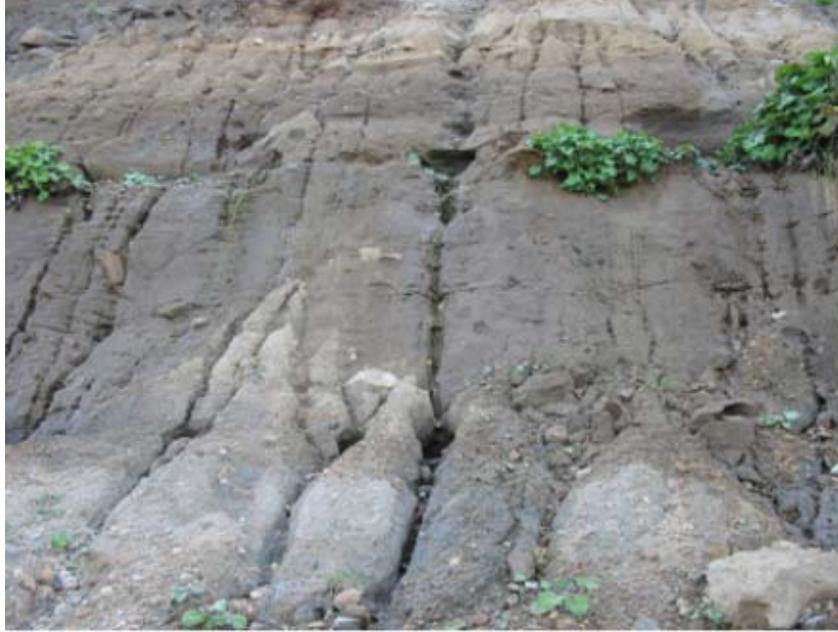
**Figure 4. Groundwater seeping out of the face of the bluff where hardpan layers outcrop results in concentrated streams of water incise the face, dislodge material and undercut the clay lenses.**

Undercutting can also occur in the face of the bluff due to ground water seepage. The bluffs on Long Island are made up of mixed sand, silt, and gravel along with clay lenses, large cobbles, and boulders. Groundwater percolating through the bluff tends to accumulate on and flow along the clay lenses. The groundwater discharges out of the face of the bluff where these clay lenses outcrop, sapping the bluff face (Figure 4). In some places along the Long Island shore a careful observer can hear the babbling of the flowing water.

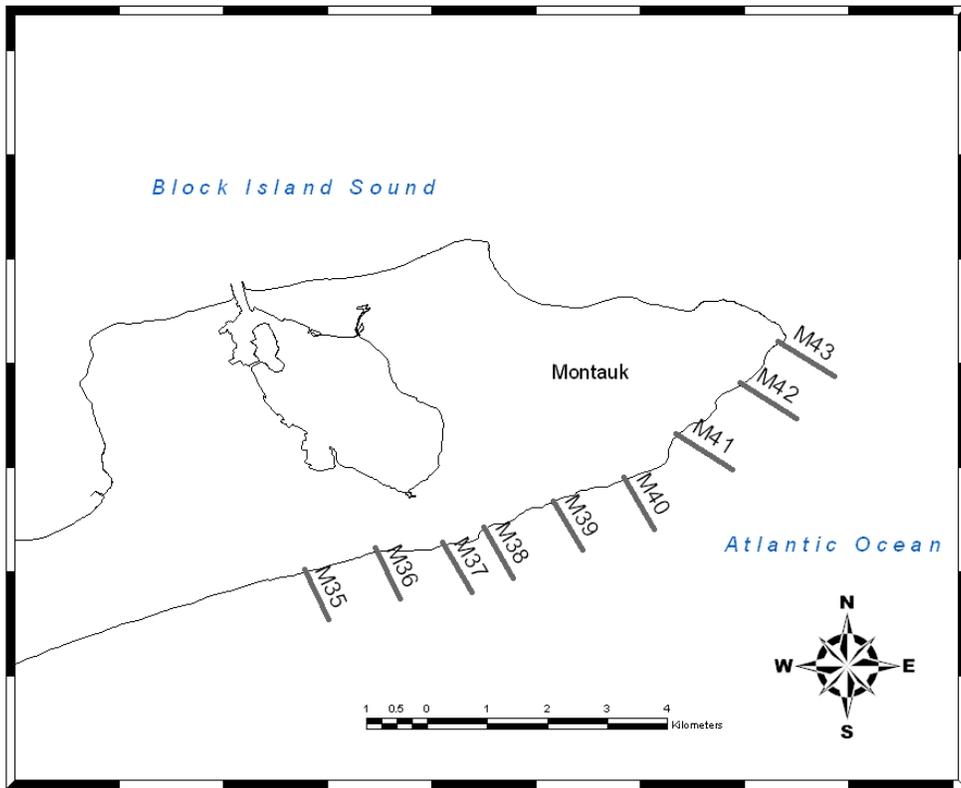
**Figure 5. Atlantic Coast of New York Monitoring Program stations within the bluff region of the Montauk Reach.**

The monitoring program subdivided the south shore into eight geographic reaches, based on geomorphology and spacing of tidal inlets. The reaches include: Coney Island, Rockaway, Long Beach, Jones Island, Fire Island, Westhampton, Ponds, and Montauk. The Ponds and Montauk reaches comprise the headland province previously discussed. For the Montauk reach eight surveys were performed between spring 1995 and spring 2001 at 43 stations. Although the Ronkonkoma Moraine runs the length of the south fork, the bluffs are not directly exposed to the coast until ACNYMP Station M35 (Figure 5).

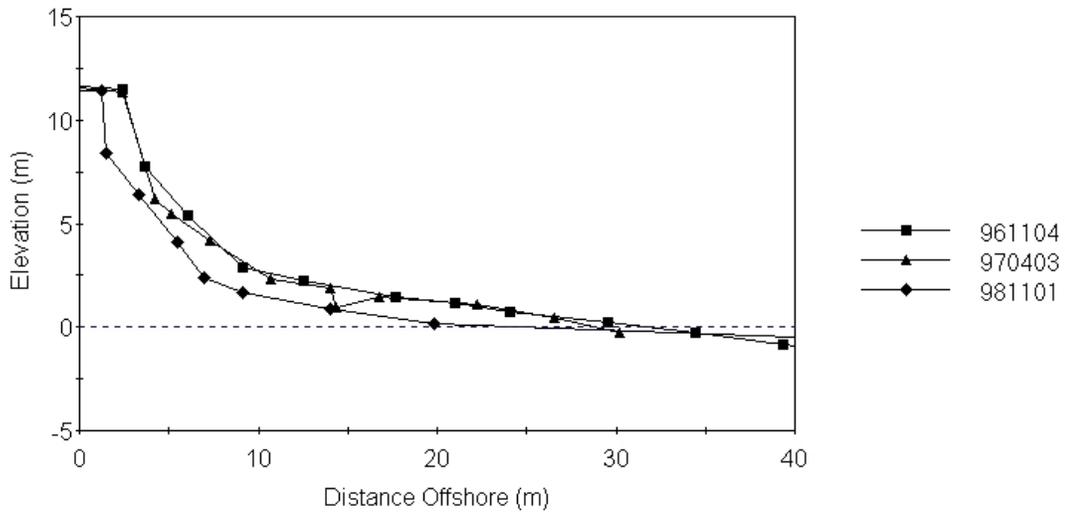
**Figure 6. Station M38. Bluff elevations are relative to NGVD 1929.**

**Undercutting of the bluff toe and mid-face erosion may have led to an unstable configuration which could have triggered a large mass wasting event resulting in the crest receding 1.2 m between 4/3/97 and 11/1/98.**

Also illustrated in the profiles are mass wasting events triggered by unstable slopes that result from undercutting of the toe and mid face erosion (Figure 6). Profiles collected at ACNYMP Station M38 indicate the bluff crest location was stable between November 1996 and April, 1997, however the toe was undermined by wave activity and the mid face of the bluff eroded (between 4 and 7 m elevation relative to National Geodetic Vertical Datum (NGVD) 1929), steepening the profile. This unstable configuration could have stimulated a mass-wasting event, which may have been responsible for the observed 1.2 m recession of the bluff crest between April 1997 and November, 1998.

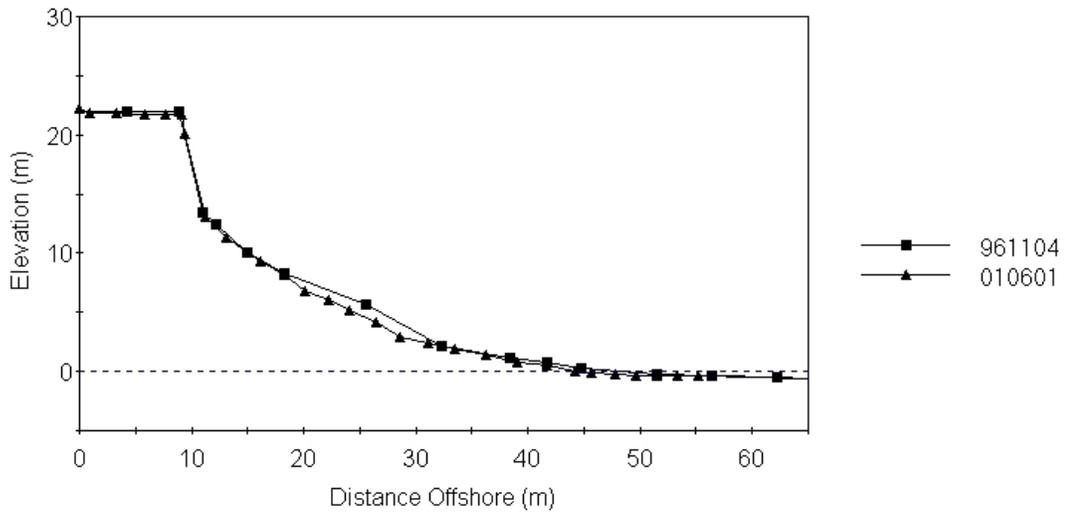
**Figure 7. Station M40. Bluff elevations are relative to NGVD 1929. Profile indicates recession of the toe between 11/96 and 6/01. Bluff crest remained stable resulting in a steeper slope of the face. The rate of recession for this station was low (0.06 m/yr) however sediment was still supplied to the littoral drift at a rate of 1,450 m<sup>3</sup>/yr.**

Bluff recession and contribution of material to the littoral drift is difficult to estimate because of episodic mass wasting events and partial removal of material from the bluff face and toe. Station M40 indicates recession of the toe approximately 3 m between November, 1996 and June, 2001 (Figure 7). During this period the location of the bluff crest remained stable. In addition Station M41 eroded mid face between December, 1995 and June, 2001, leaving both crest and toe positions relatively fixed (Figure 8). Erosion of these two stations resulted in steeper profiles that may eventually lead to larger mass wasting events. However for this time period these two stations exhibited the lowest overall recession rates even though their annual contribution to the littoral drift was approximately  $2,150 \text{ m}^3$ . The changes depicted at these two stations would be imperceptible from aerial photographs and therefore material contributed through erosion of these bluffs using this technique would not have been incorporated into earlier littoral budgets.

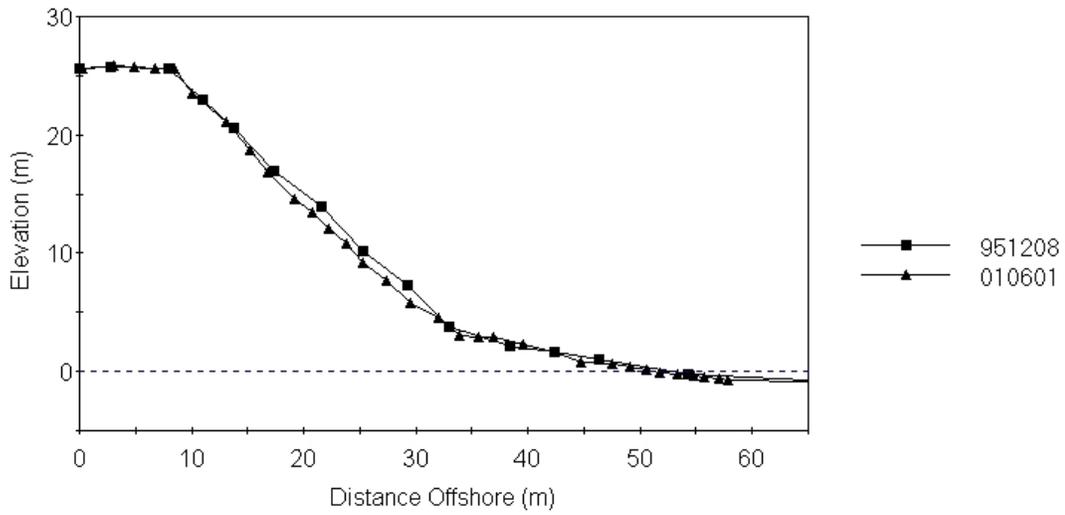
**Figure 8. Station M41. Bluff elevations are relative to NGVD 1929. Sediment eroded from the middle of the bluff face between 12/95 and 6/01, preserving both crest and toe locations. Although the rate of recession for this station was higher than station M40 (0.09 m/yr) less sediment was supplied to the littoral drift (700 m<sup>3</sup>) annually.**

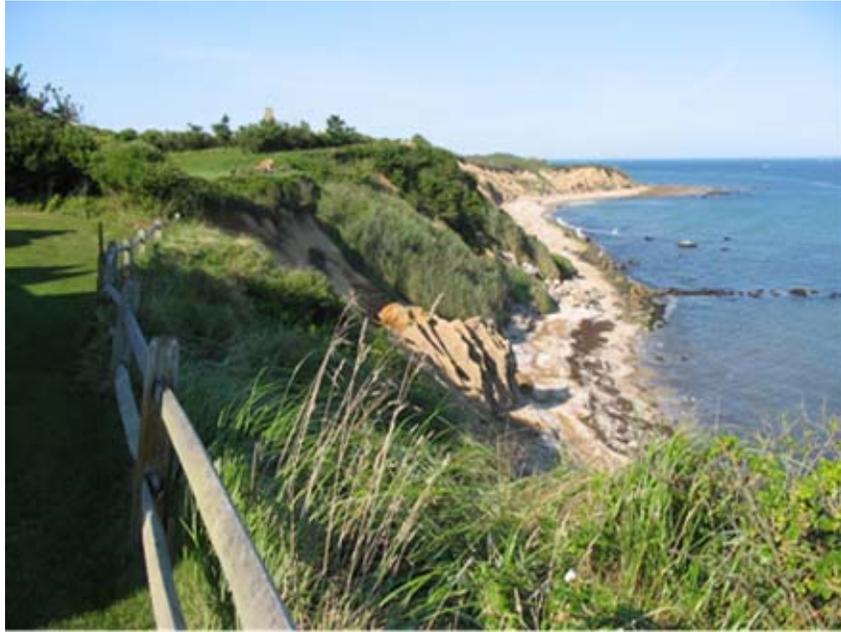
**Figure 9. Slope reduction and vegetation appear to be the most effective stabilizing techniques. Regions of the coastal bluffs that have been stabilized with these mechanisms experience decreased recession rates.**

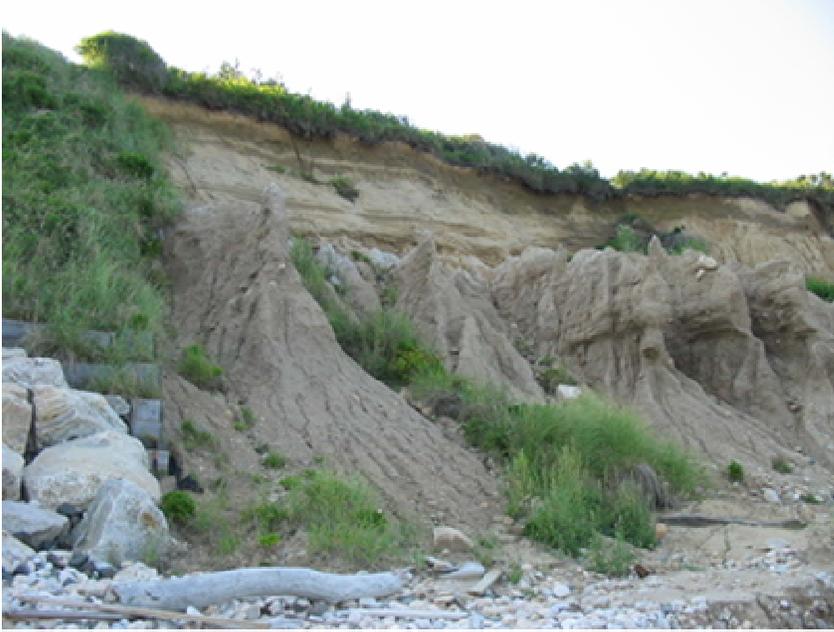
**Figure 10. Bluff recession is intensified for non-stabilized regions. Erosion along the flanks of stabilized bluffs can undermine protective structures and often require periodic maintenance. Hardpan layers are visible in the photograph and long term incising of groundwater across the face has carved ridge structures, seen protruding from the face.**
